**State of Utah**  
**DEPARTMENT OF NATURAL RESOURCES**  
**Division of Oil, Gas & Mining**

**Inspection Report**  
**Minerals Regulatory Program**  
**Date of Report: July 9, 2008**

**Mine Name:** Bromide Basin  
**Operator Name:** Unico

**Permit number:** S0170031  
**Inspection Date:** July 2, 2008  
**Time:** 2:30-3:50 PM

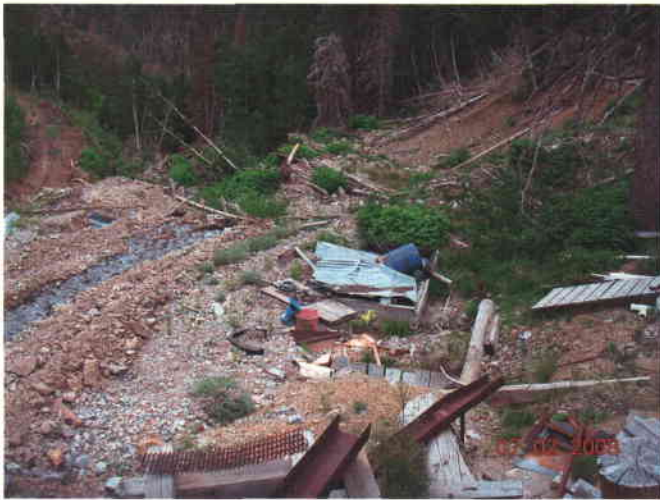
There is a large amount of miscellaneous equipment and trash around the site, including old steel cans, a fuel storage tank, a lot of pipes and hoses, a compressor, a pump, corrugated steel, and many pieces of metal and other items whose use I do not know (Photos 1, 2, and 5).

**Photo 1.** This shows miscellaneous debris below one of the structures I believe to be a tippie.

The operator needs to clean up this site and get rid of, or neatly consolidate, all the miscellaneous debris. The barrel, oil bucket, and oily water need to be removed and properly disposed of. I will be taking enforcement action requiring that this be done.

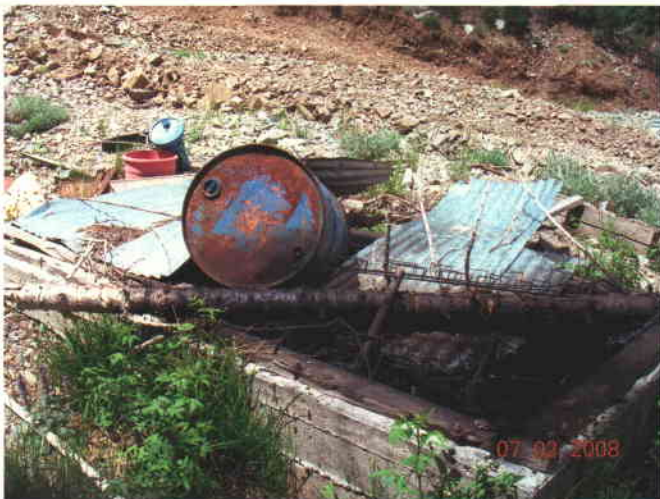
Just below the entrance road is a concrete structure in which there was a barrel and an oil bucket. The structure was filled with water and oil (Photo 2).

**Photo 2.** A concrete structure filled nearly to the top with oil and water. It is about 10-15 feet from the stream.

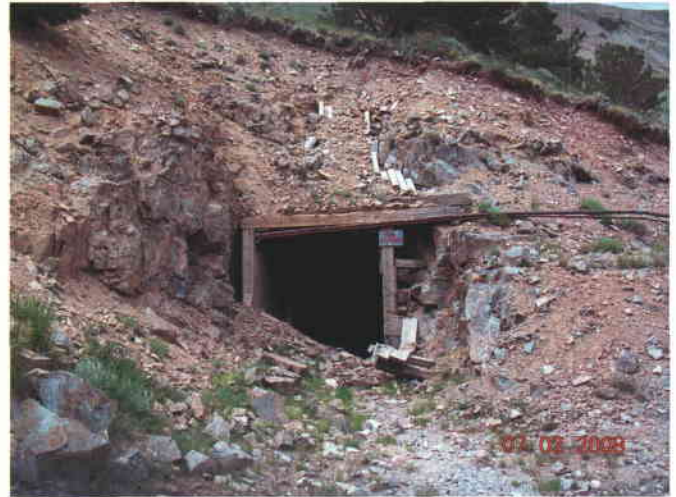
The mine has three portals which are all open (Photos 3, 5, and 8). Two of them are partly closed by rockfalls. They do not have gates or anything else preventing access.

**Photo 3.** One of the two portals in the upper portion of the mine site.

My report for the August 28, 2006, inspection said I would issue a notice of violation if, by the next inspection, the portals were not secured to prevent entry by the public. This has not been done, so I will be taking enforcement action.

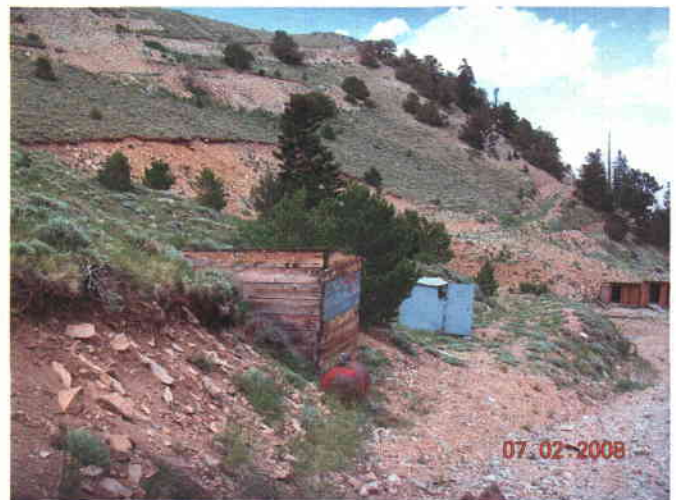
**Photo 4.** Three shacks and the explosives magazine in the upper portion of the mine.

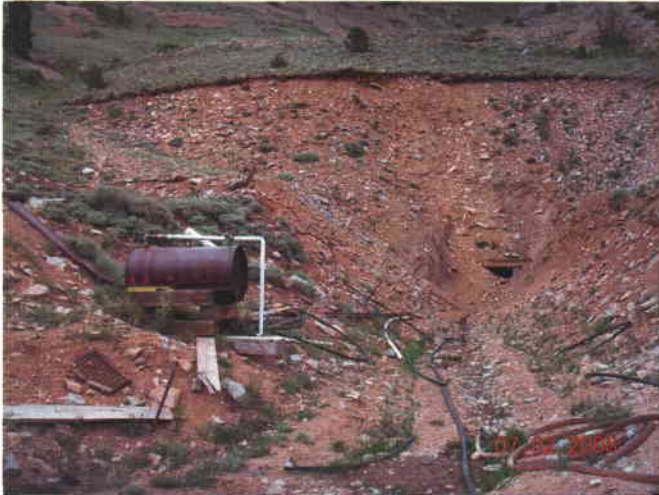
**Photo 5. The second open portal in the upper portion of the mine.**

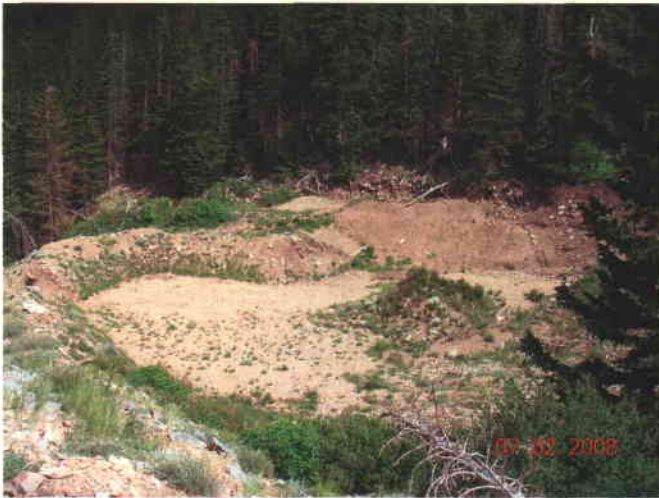
Other facilities at the site include an outhouse and a small collapsed shed next to a bunkhouse (Photo 7), an explosives magazine, three sheds, about three ponds (Photo 6), and one or two tipples. It is hard to tell whether both of the structures are tipples because they are in bad repair.

**Photo 6. One of the ponds.**

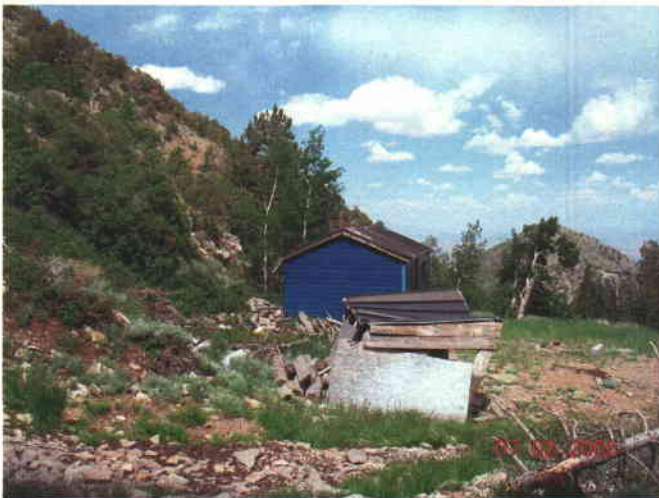
**Photo 7. This bunkhouse and partially-collapsed shed are next to the Middle Mine.**

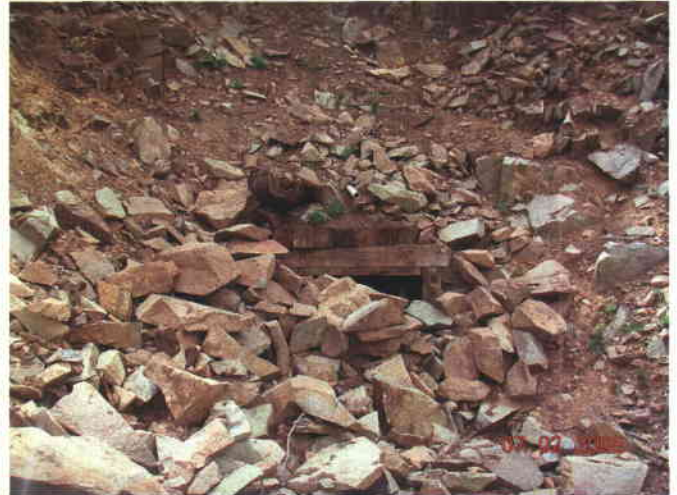
**Photo 8. The Middle Mine portal.**

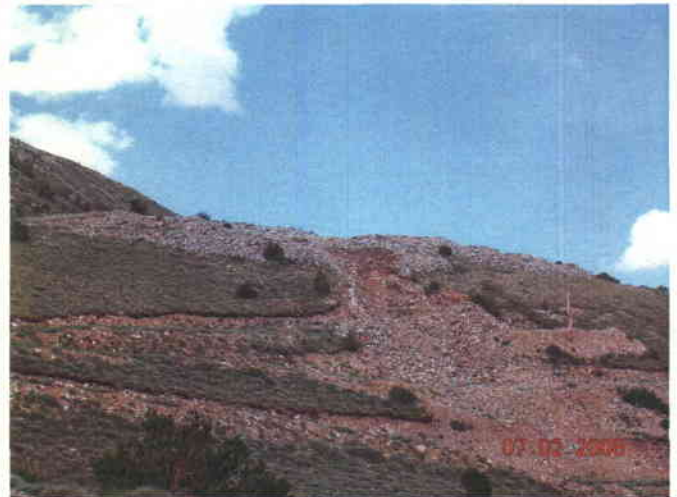
There are a lot of disturbances on the mountain above the upper portals, but I understand these are not the operator's responsibility.

**Photo 9. There is a lot of disturbance on the mountain above the permitted mine. In this picture, it appears part of the waste pile has failed or eroded badly..**
